Manhole Inspection Summary

Manhole # S25I__009MH

Inspection ☐ Is Incomplete Rating: **4) Poor**

Location Address: **1031 Holton Ave**

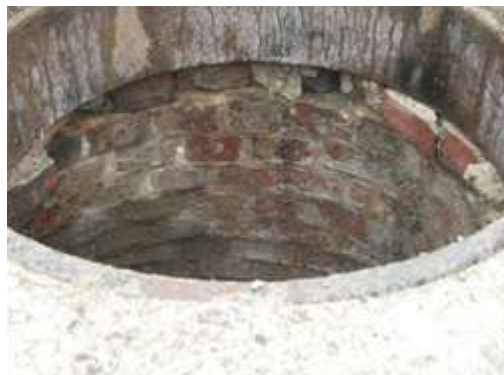
Defect 6

Frame Offset: **2** (in.) Condition: ☐ Sound ☐ Cracked ☒ **Leaks**

Condition: ☐ Sound ☐ Cracked ☐ Root Intrusion ☐ Loose Brick ☒ **Deteriorated**

Infiltration: ☐ None ☐ Joint ☐ Cracks ☒ **Mortar** ☐ Roots ☐ Wall

deteriorated chimney & infiltration, frame leaks

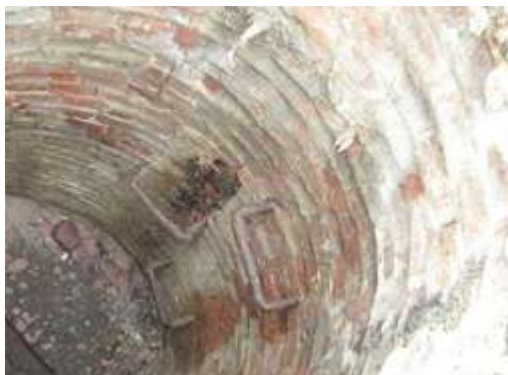
Defect 4

Steps Count: **4** Missing: **1** ☒ **Corroded**

corroded & missing rungs

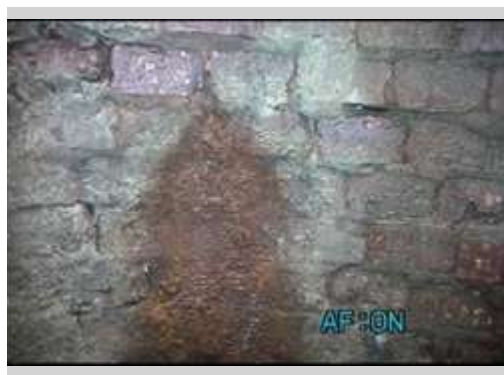
Defect 2

Infiltration: ☐ None ☐ Joint ☐ Cracks ☐ Mortar ☐ Roots ☒ **Wall**

infiltration in corbel

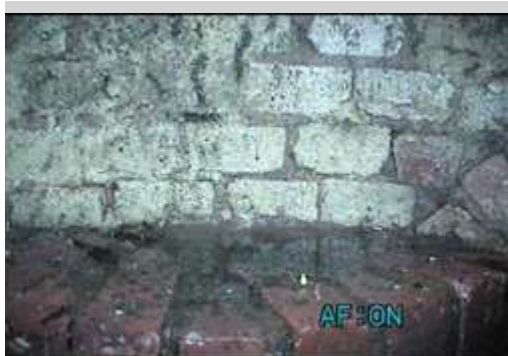
Defect 1

Infiltration: ☐ None ☐ Joint ☐ Cracks ☐ Mortar ☐ Roots ☒ **Wall**

infiltration in barrel

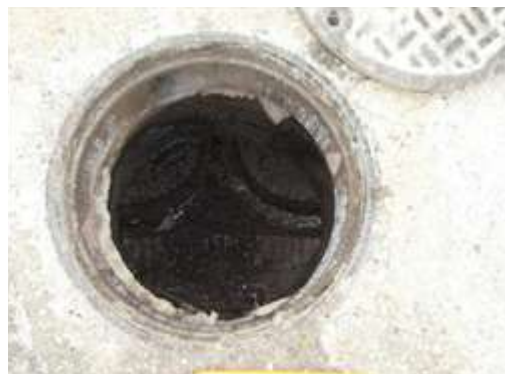
Defect 5

2" Offset depicted in photo
